Date 06-6-2018

## **Subject Water Vole Survey Results - Chesterton Bridge**

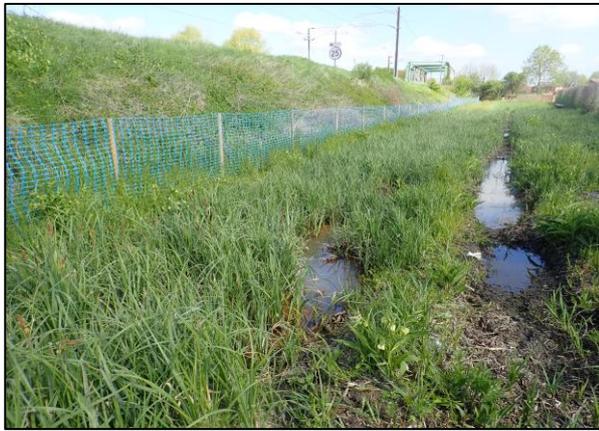
The marginal vegetation is very dense i.e. a monoculture of sedge (refer to photograph one), including an understorey of die back vegetation, which is very difficult to survey. However, the dense vegetation provides excellent cover for water voles. The downstream section is devoid of both bank and aquatic vegetation (refer to photograph two).

**Photograph 1:** View looking downstream along Coldham's Brook (view from the upstream limit of the survey).

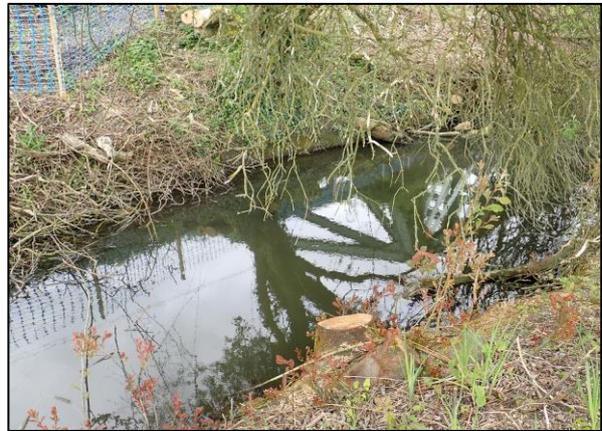
**Photograph 2:** The lower downstream section of the surveyed section
